LAKE FORREST DRIVE UPDATE

June 18, 2013

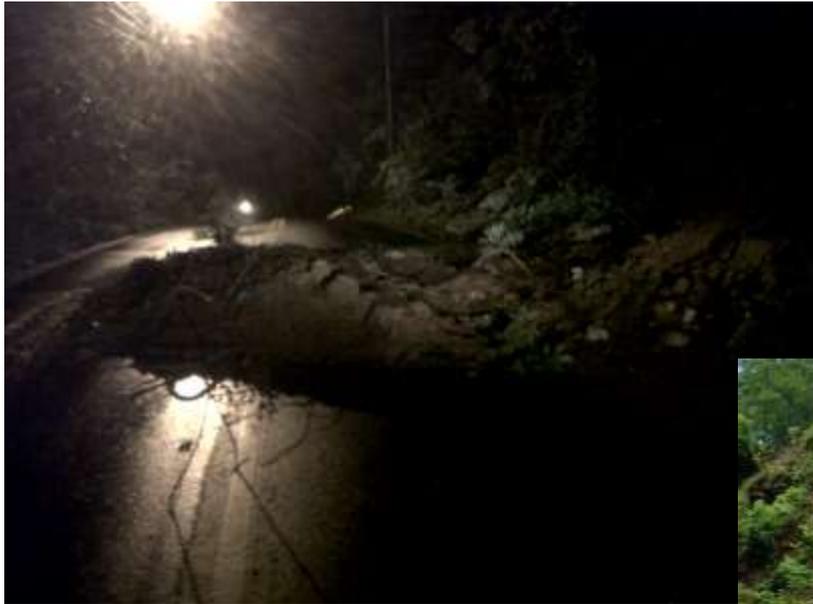
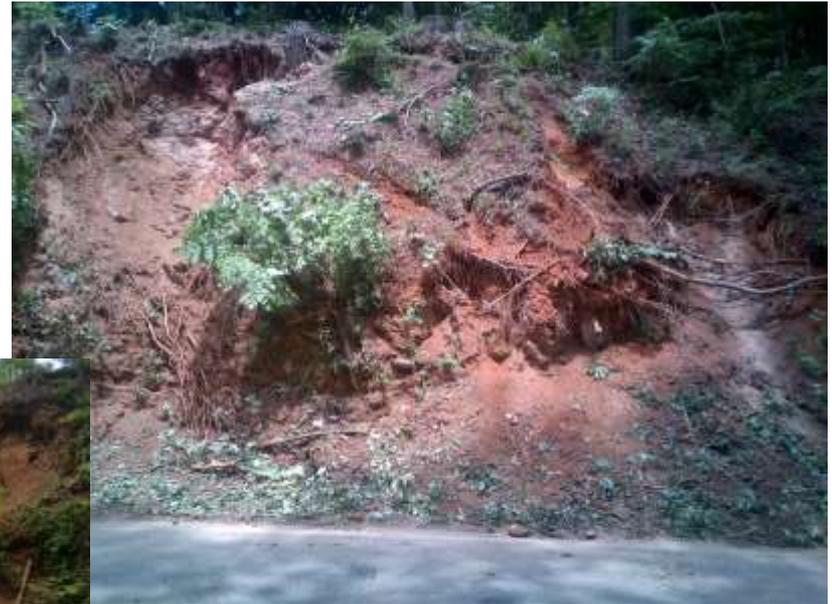
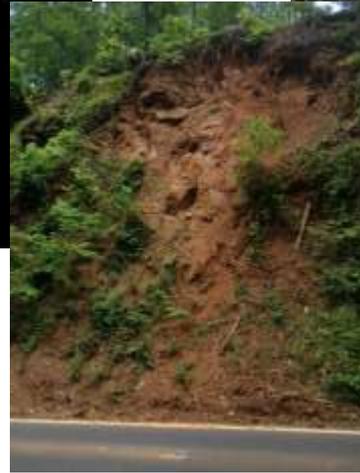
Existing Conditions

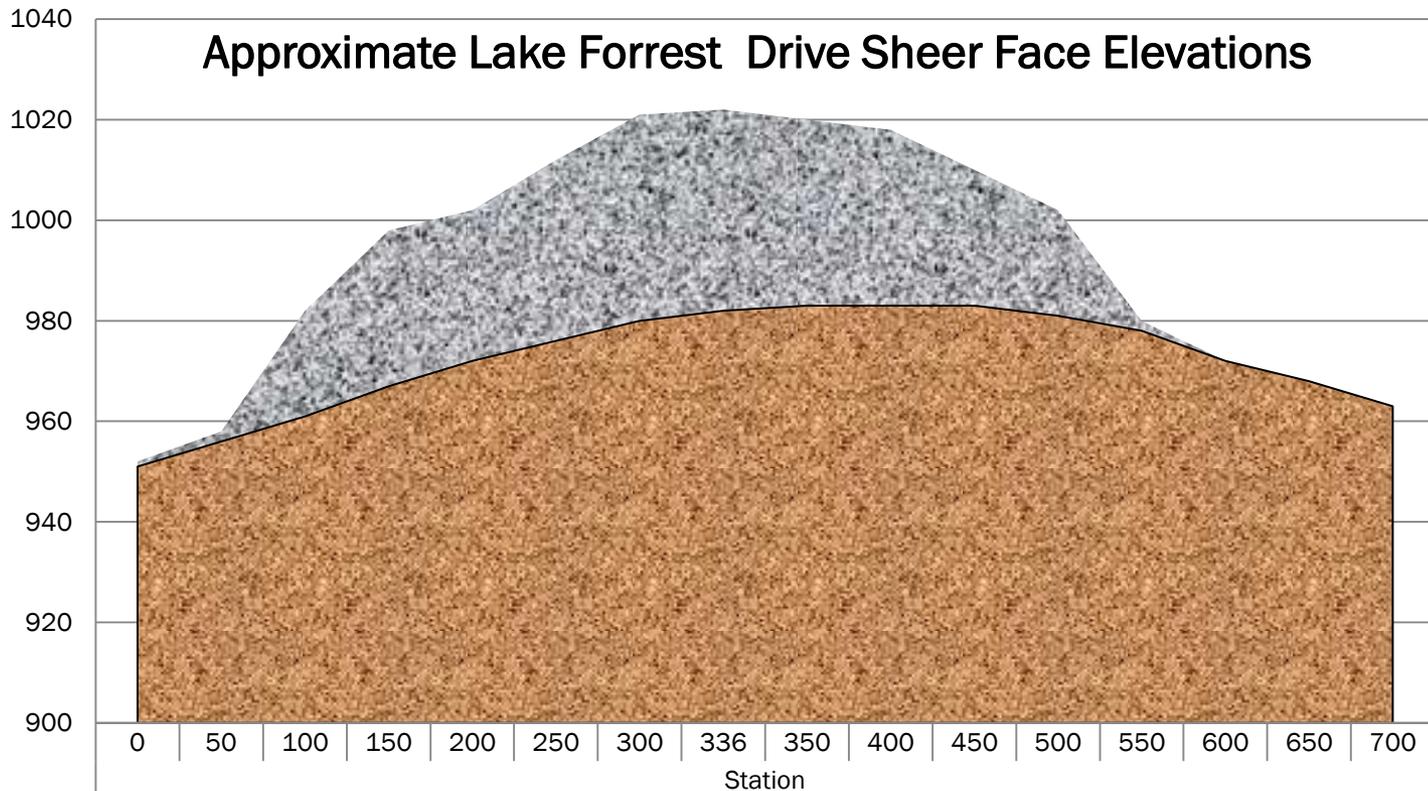
Preliminary Height Analysis

0	50	100	150	200	250	300	336	350	400	450	500	550	600	650	700
embankment (X)	952	958	982	998	1002	1012	1021	1022	1020	1018	1010	1002	980	972	967	958
Road (Y)	951	956	961	967	972	976	980	982	983	983	983	981	978	972	968	963
