STATE OF MINNESOTA  
DEPARTMENT OF TRANSPORTATION  
PAVED INVERT REPAIR  
CORRUGATED METAL PIPE

STANDARD  
PLATE  
NO.  
3X02  
1 OF 2

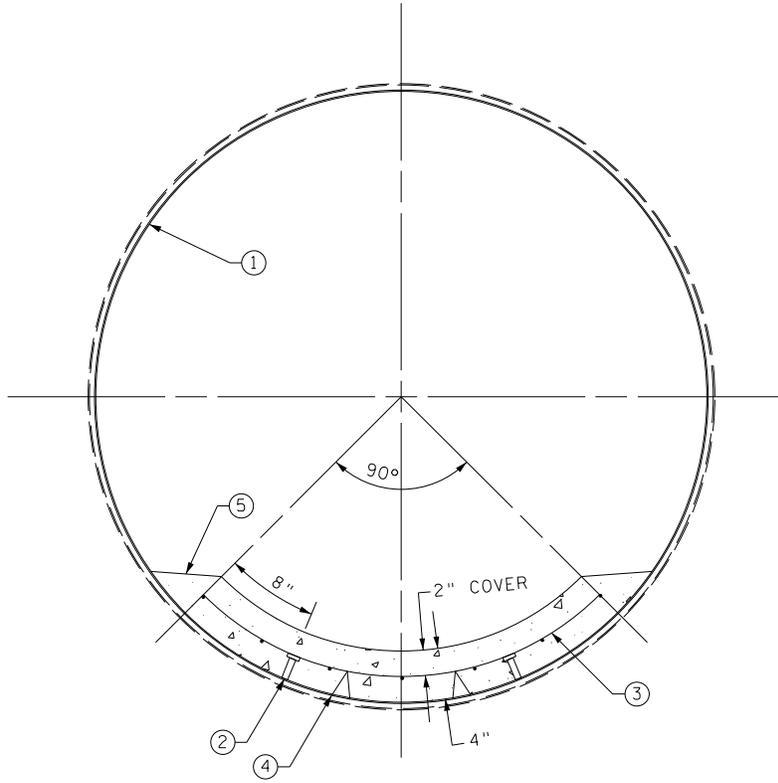
SECTION A-A  
PARTIAL INVERT DETERIORATION

- ① CORRUGATED STEEL PIPE WITH PARTIALLY DETERIORATED INVERT.
- ② 3/8" DIAMETER X 2" HEADED STUDS WELD TO CREST OF CULVERT CORRUGATION.
- ③ WELDED WIRE FABRIC REINFORCEMENT ROLLED TO RADIUS OF EXISTING CULVERT PIPE. PROVIDE 6 X 6-W5 X W5 WWF OR EQUIVALENT AREA (BASED ON 0.2% REINFORCEMENT AREA TO GROSS CONCRETE AREA).
- ④ SUPPORT TO MAINTAIN 2" CLEAR COVER ON REINFORCEMENT.
- ⑤ SLOPE CONCRETE TO DRAIN, 1/2" SLOPE, MINIMUM.
